Manhole Inspection Summary

Manhole # S43I__045MH

Insp Date: **4/29/08 3:59 PM**

Location Address: **330 s broadway**

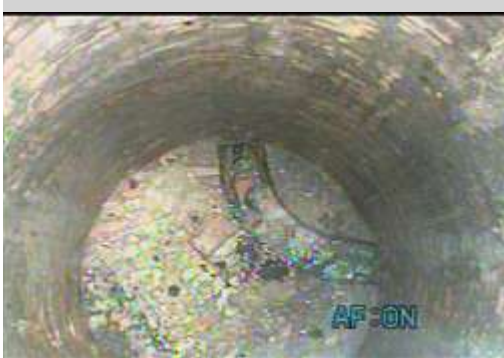
Defect 4

Condition: ☐ Sound ☐ Cracked ☐ Root Intrusion ☐ Deteriorated ☐ Leaks ☒ **Debris**

bench and channel debris

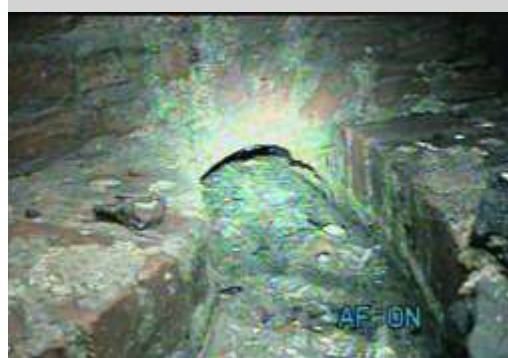
Defect 3

channel debris

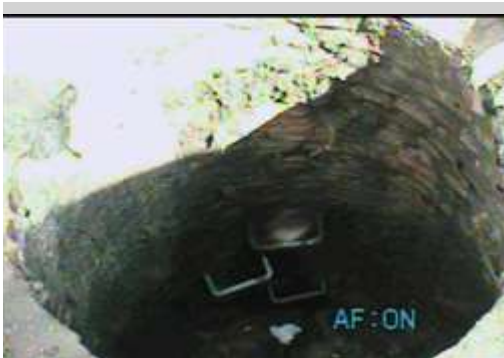
Defect 2

Infiltration: ☐ None ☒ **Joint** ☐ Cracks ☐ Mortar ☐ Roots ☐ Wall

Steps Count: **5** Missing: **2** ☐ Corroded

corroded stairs, corbel and barrel leaks

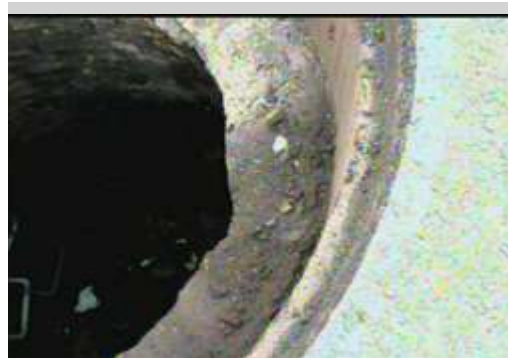
Defect 1

Frame Offset: **5** (in.) Condition: ☒ Sound ☐ Cracked ☐ Leaks

off set frame

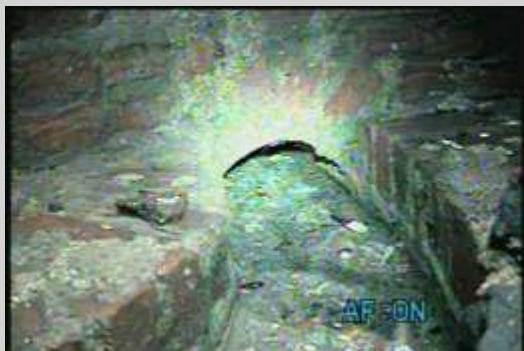
3 O'Clock Inflow

Deposits: ☐ None ☐ Mud ☐ Sludge ☒ **Debris** ☐ Grease

Silt Depth: 6 (in.) Deposits Extent: **Heavy**
